# Bearings & Power Transmission Pty Ltd

## Case Study

### **Chain Conveyor Breakdown brought production to a standstill and how BPT helped repair and restore production in record time.**

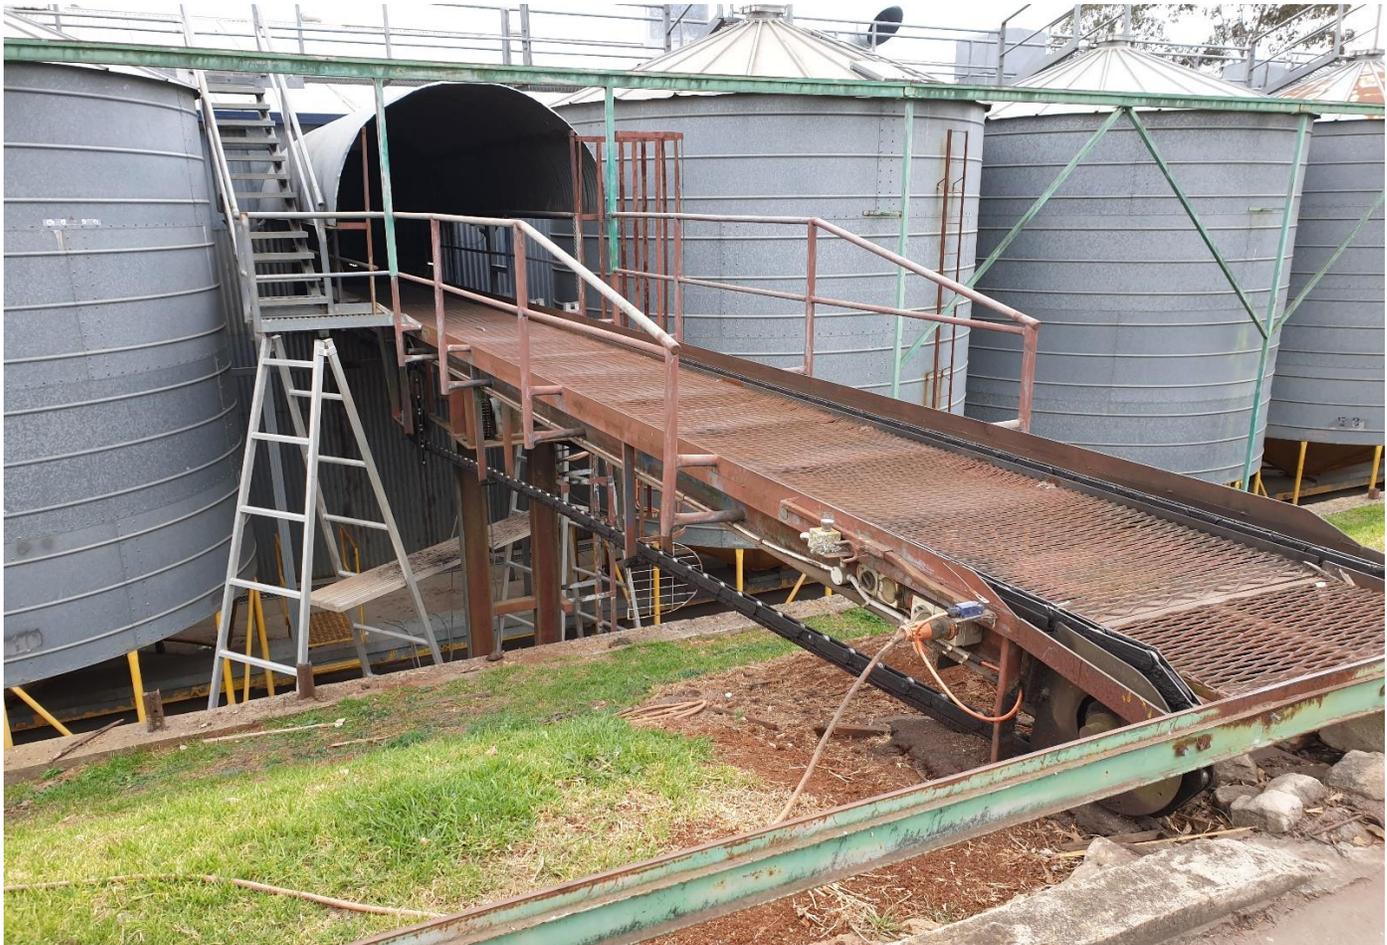
The main conveyor, which transports product ingredients from the storage shed to the factory had broken down.

**Main Conveyor**

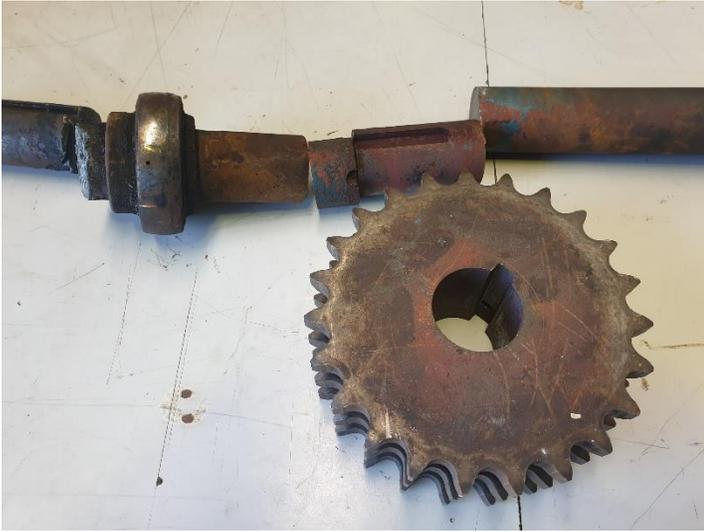
## **Broken Shaft and Main Drive sprocket**

After onsite meeting with chief maintenance officer, we put a plan in place to have a new shaft machined up and fit weld-in hubs into the old sprockets to fix the damage to the inside of the old cast sprockets.

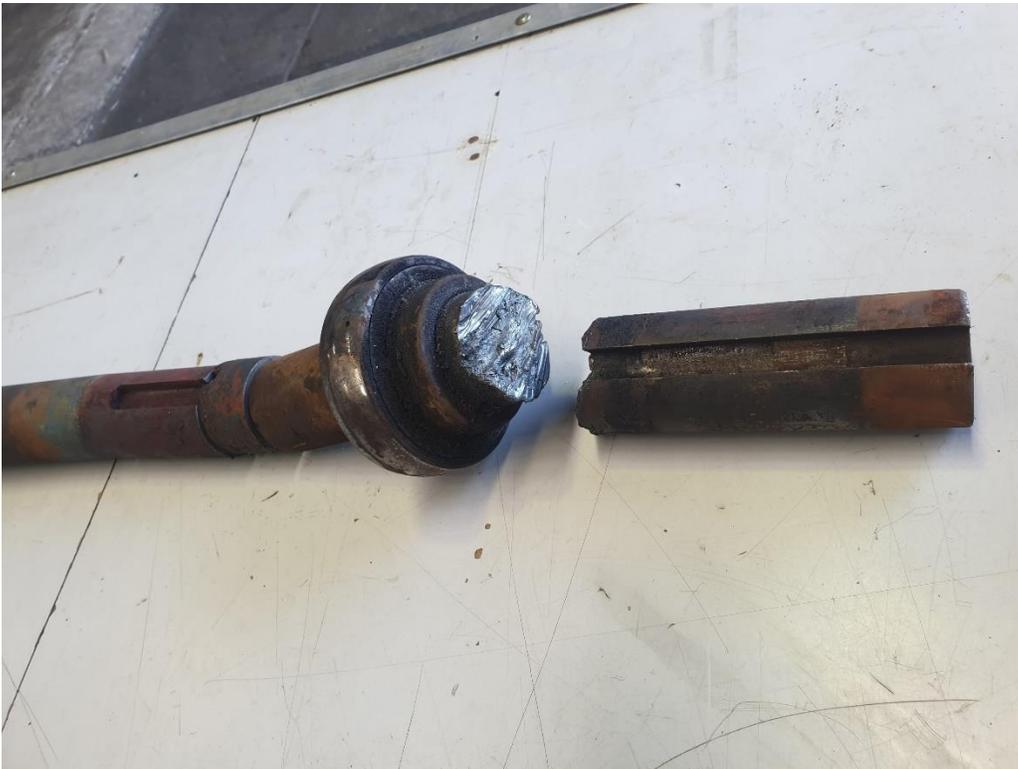
**Broken Shaft needed replacing.**

Through BPT's preferred local machine shop, Daniel organised to fabricate a new shaft, c/w keys to avoid the chain from rubbing on the frame work and machining of the old cast sprockets to suit the weld-in hubs. Using weld-in hub was a better long-term solution than welding directly onto the shaft. The shafts were machined to take the stepped weld-in hubs, then High Strength self-locking retainer units was used to lock them in place.

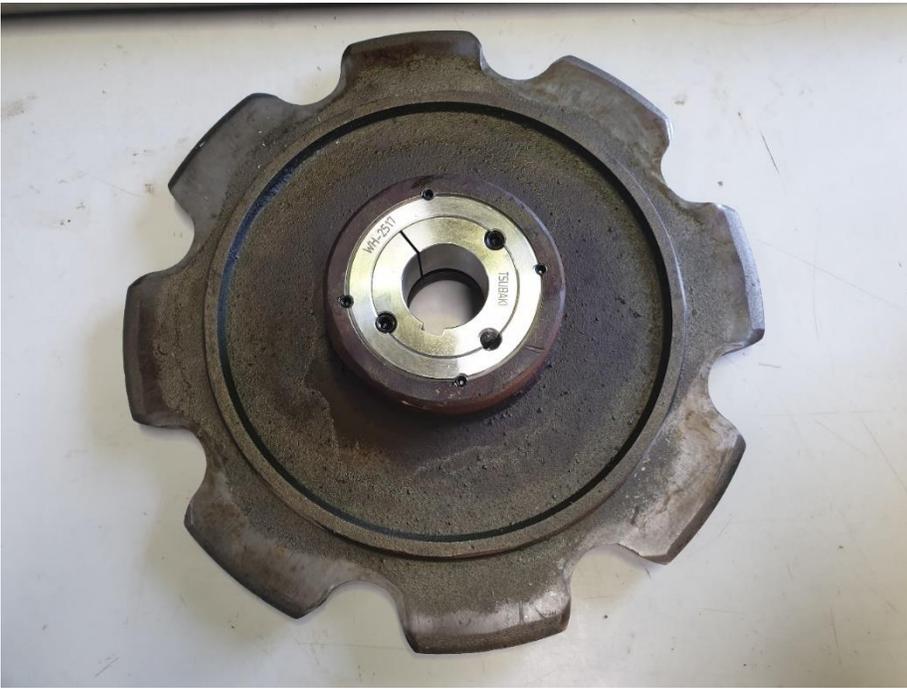
**Close up look of Cast Iron sprocket with weld-in hubs**

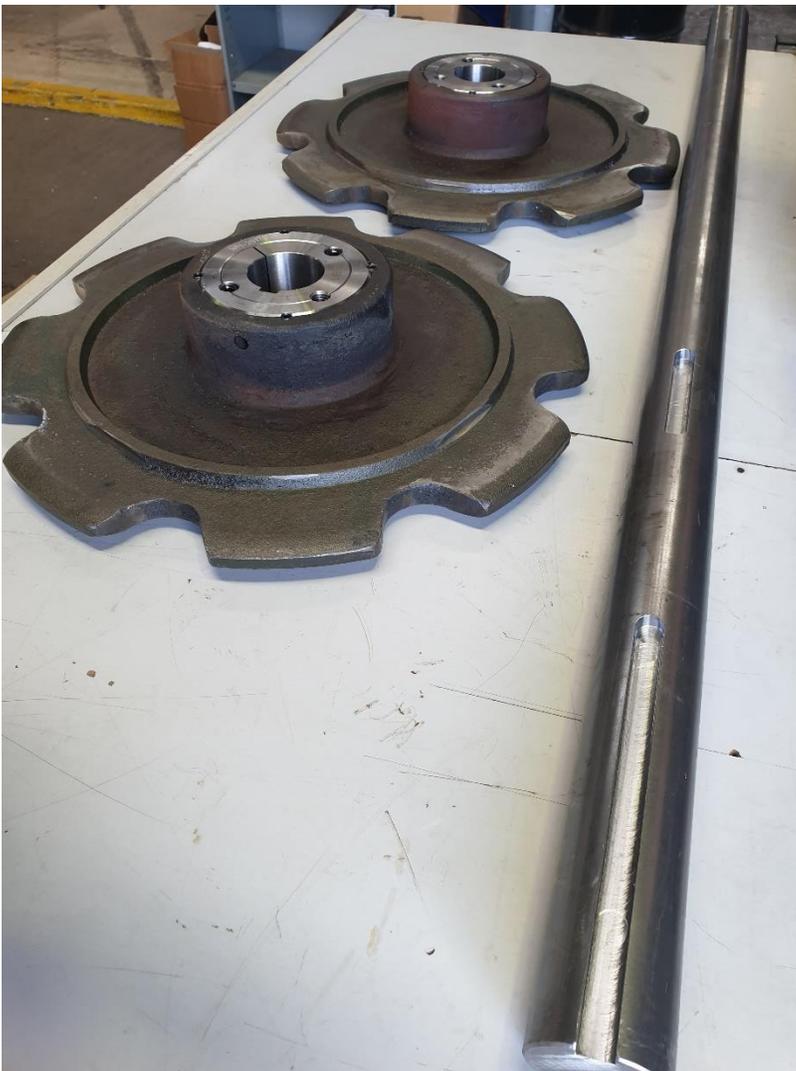
**New drive shaft and old cast sprockets with weld-in hubs**
