Ribbon Mixer Case Study

The power transmission driving this mixer is a Cyclo Sumitomo 619 series gearbox with a 11.1 reduction.

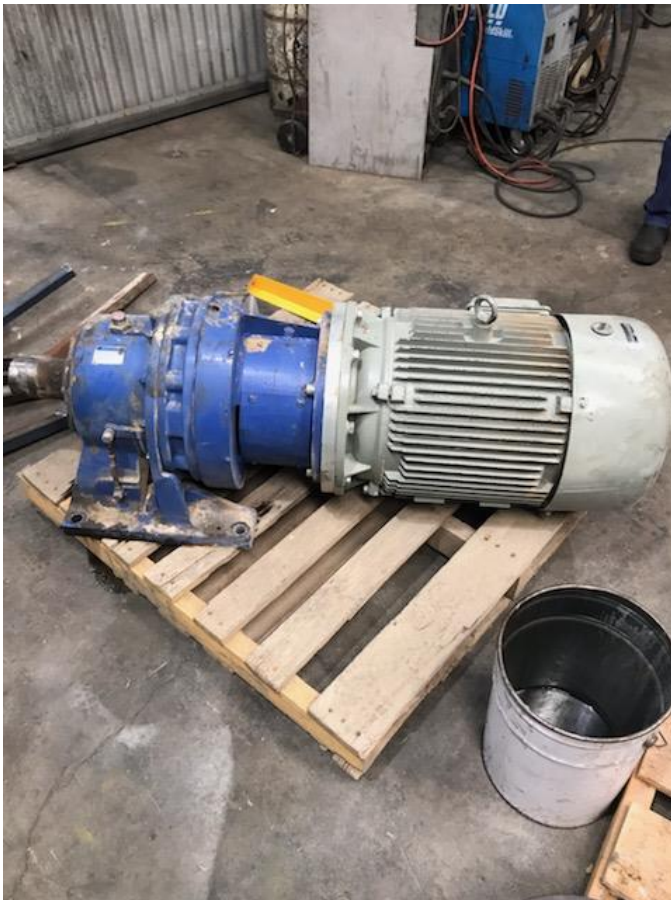
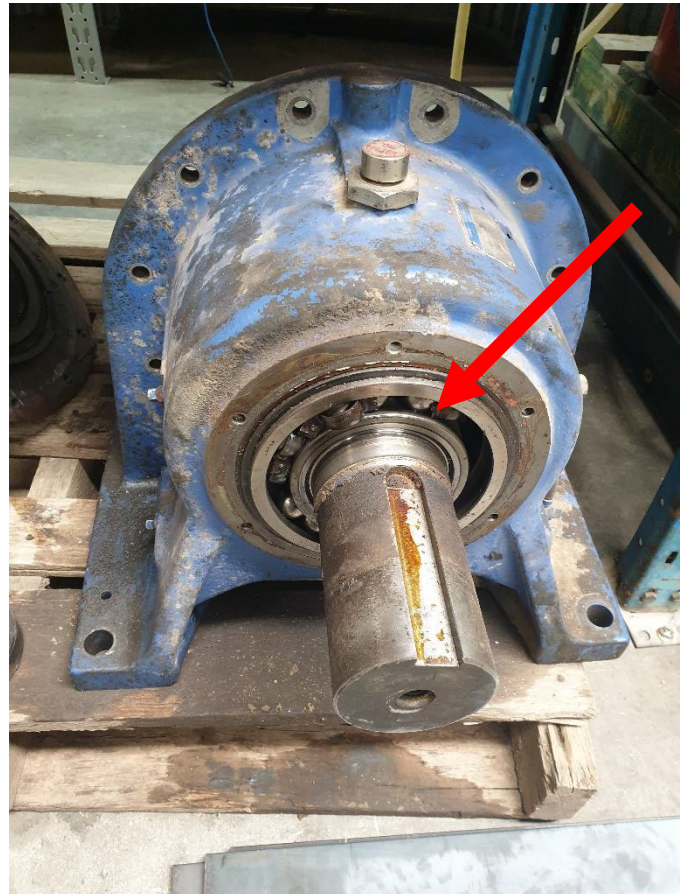
At the end of 2019, it started developing some weird noises.

After inspection, we found the outer bearing had failed.

So, we had it pulled out and replaced with their identical spare gearbox they have had on hand since the first one was put into service. Due to the nature of this particular business they have elected to always have a backup spare gearbox on hand because they can't afford any downtime while waiting for a replacement gearbox.

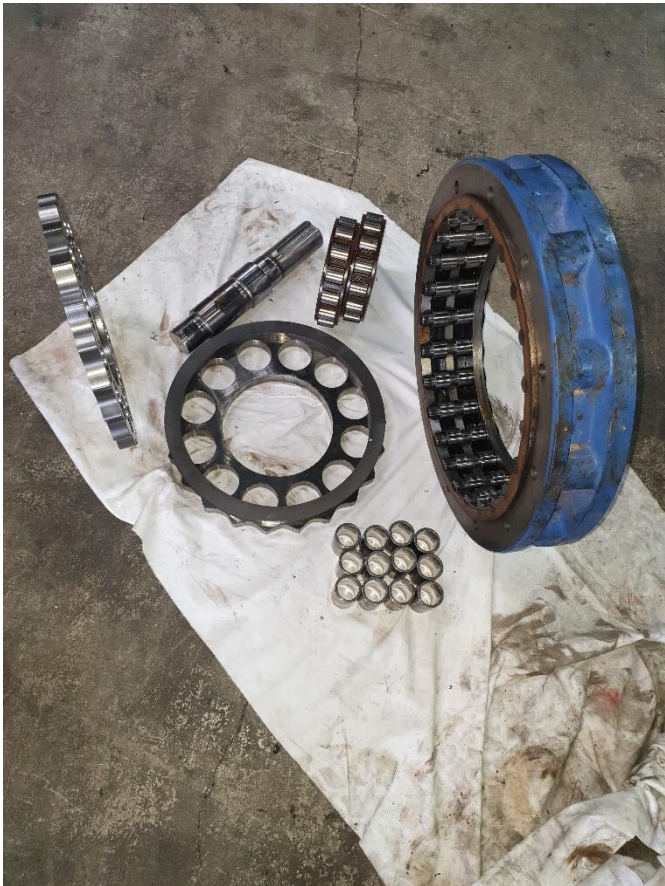
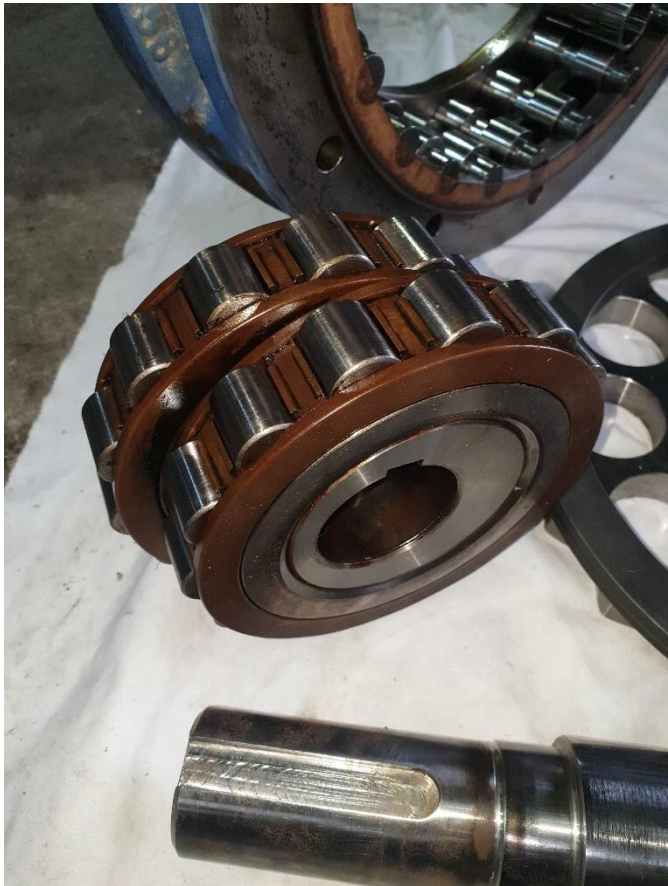
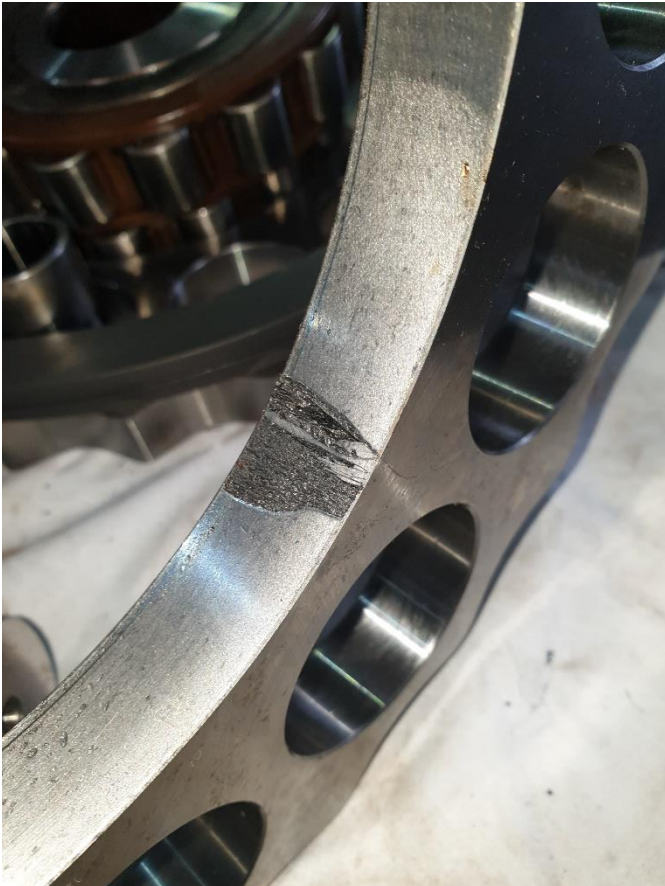
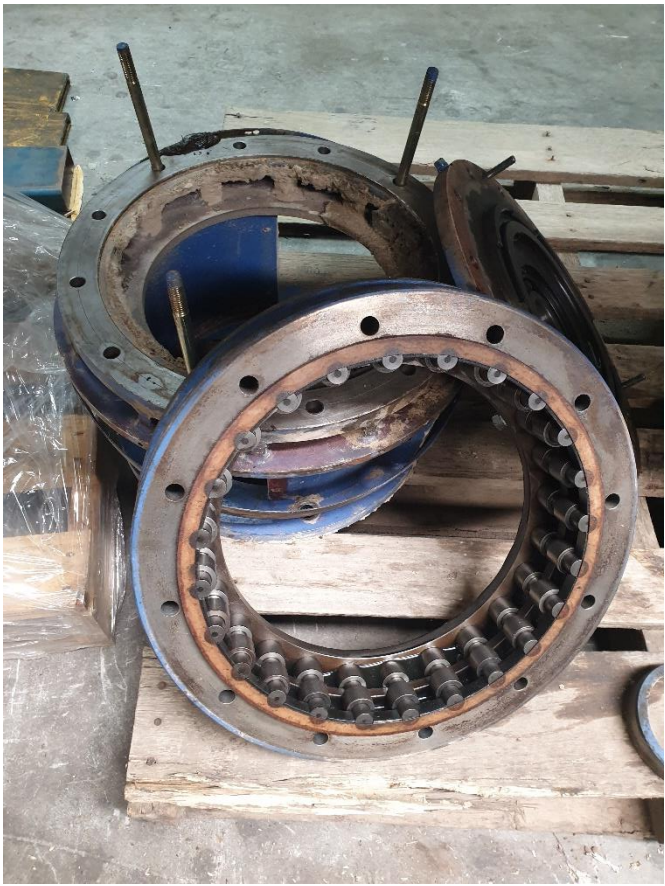
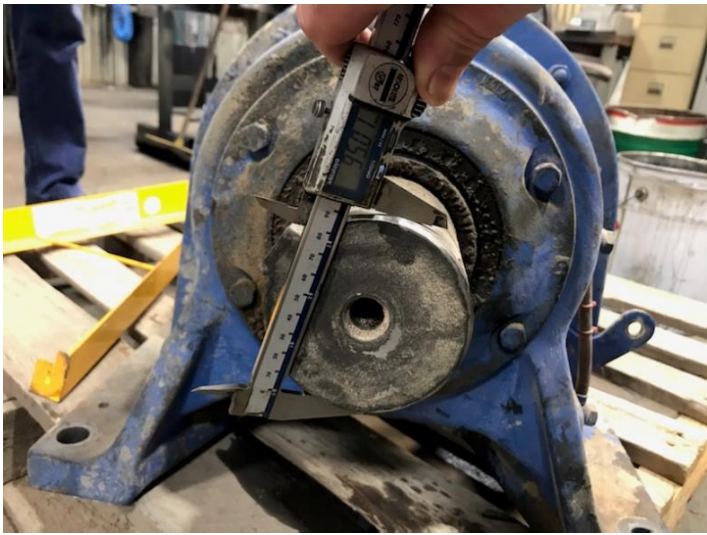
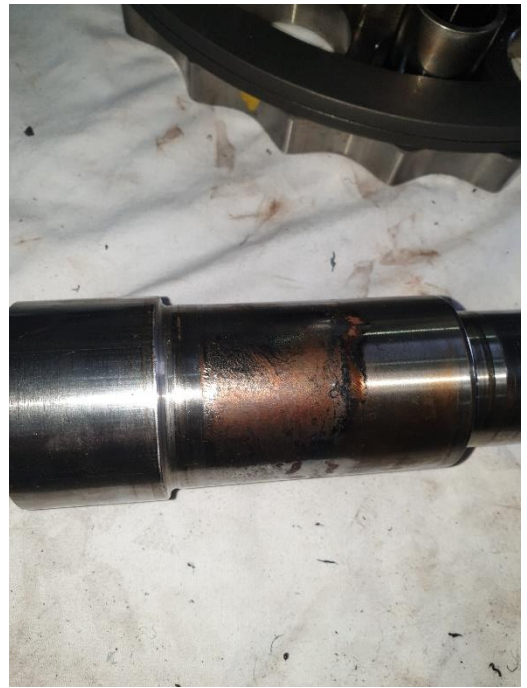
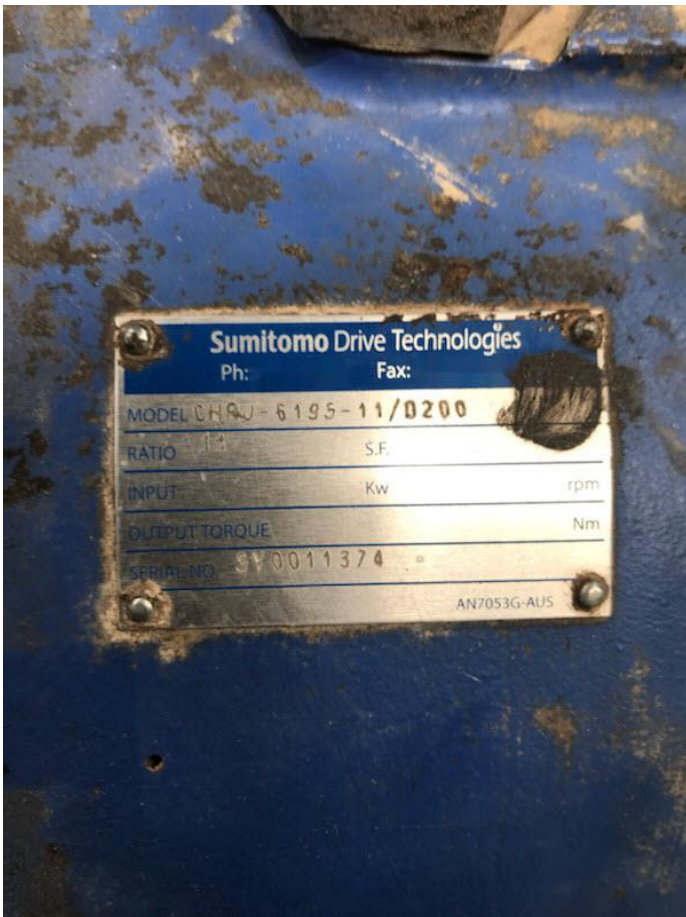
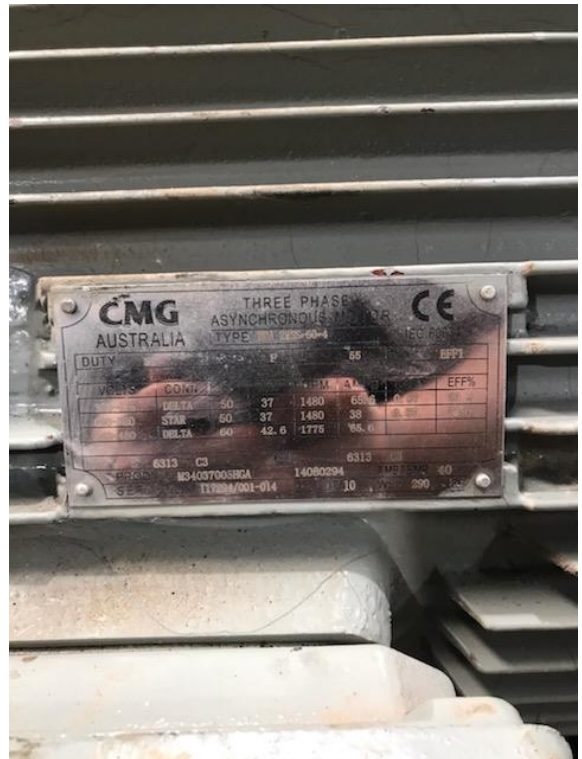
We found that not only had the outer bearing failed, there was damage throughout the whole gearbox.

BPT had the gearbox stripped down.

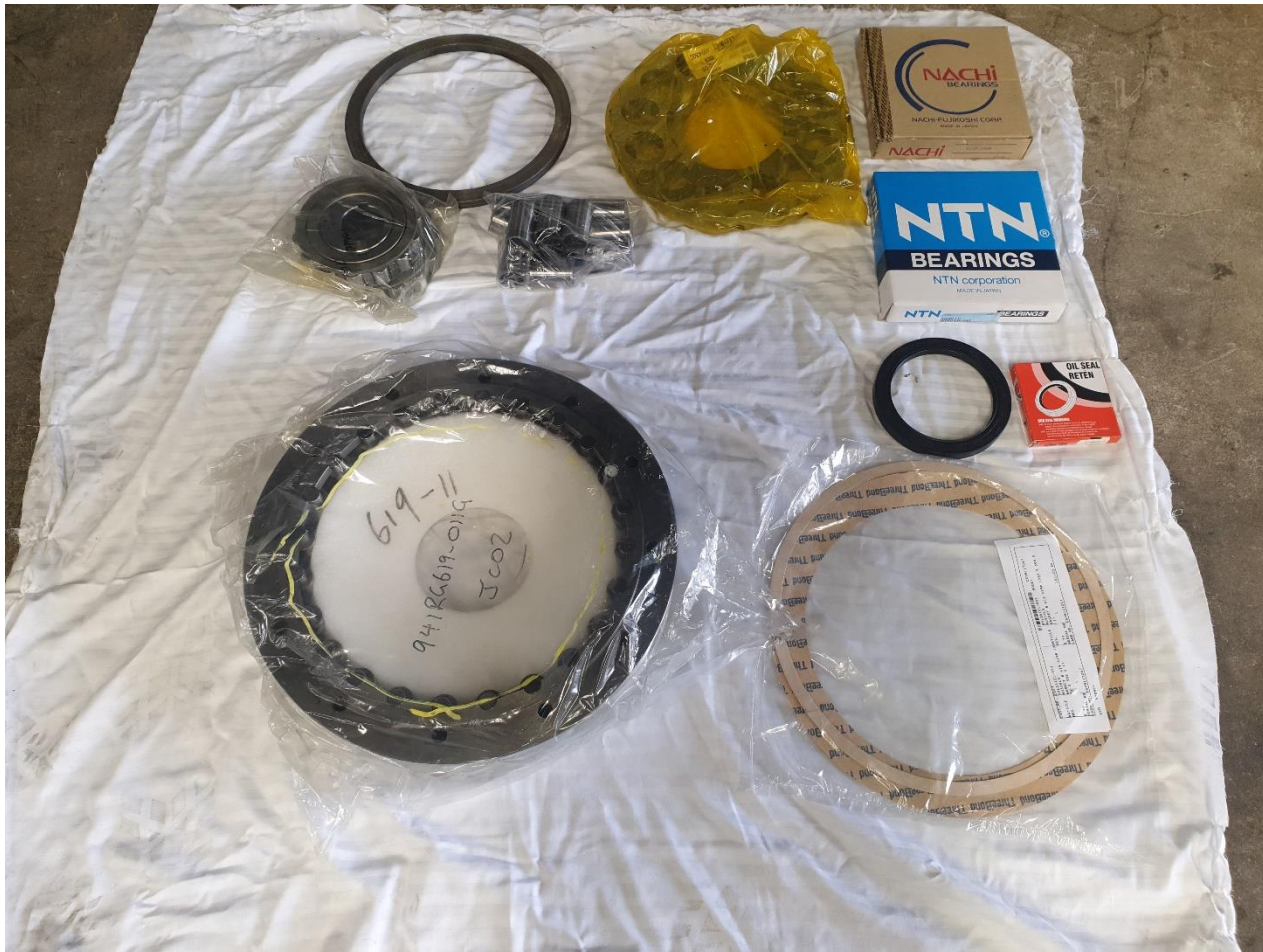
One of the advantages with the Cyclo Sumitomo gearbox is we could replace the cartridge and all the moving parts inside that gearbox and just keep the housing and the output shaft.

When rebuild, BPT replaced every bearing, seal and gasket.

The only parts reused was the housing and output shaft which is 95mm diameter on the slow speed output side.

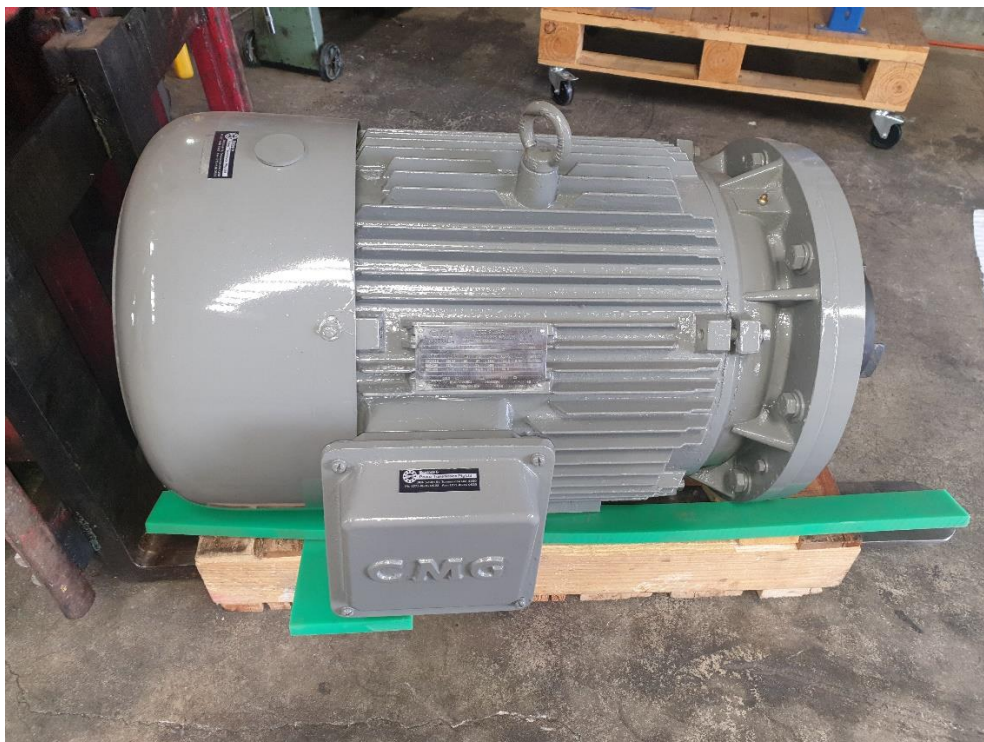
So, the electric motor was stripped down cleaned, new bearings and V rings were fitted.

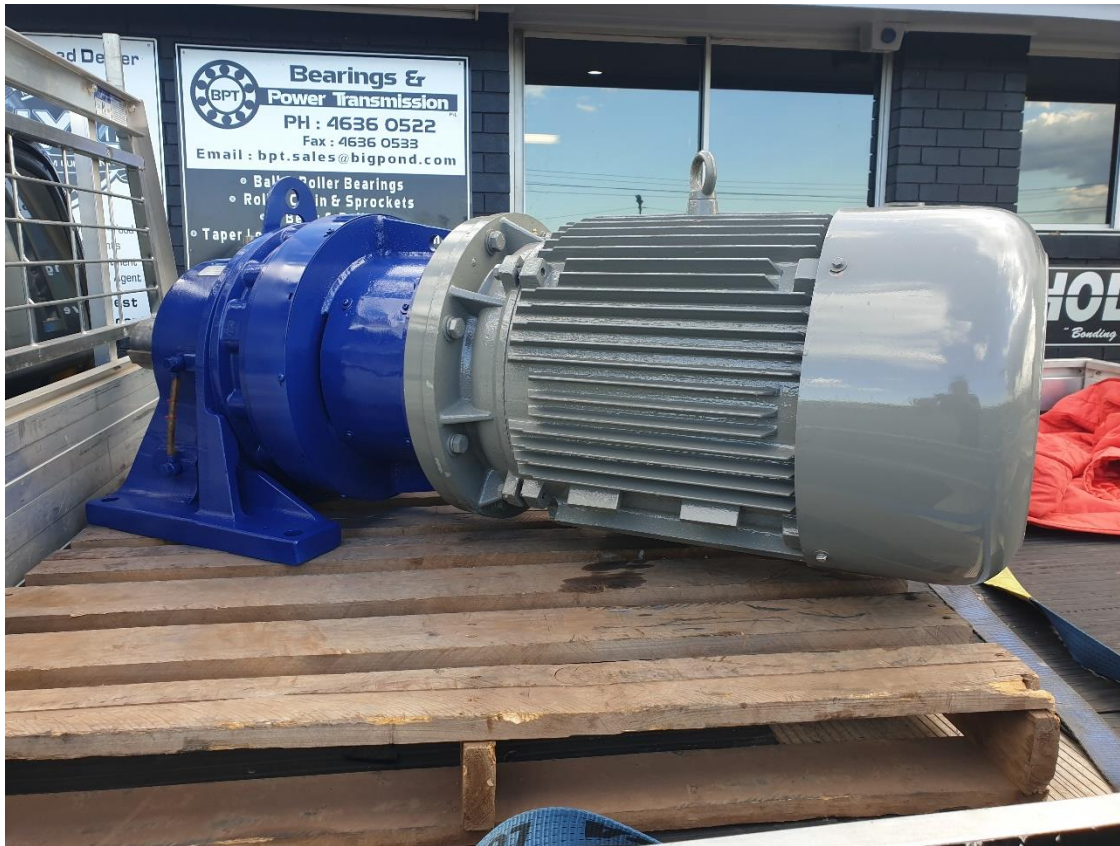
The completed reconditioning of the electric motor and full rebuild of the gearbox including the cartridge came in at 11,000 dollars total.
